# Practice Makes Perfect

*Refinishing  
Regina Oceani's  
middle-aged hull*

By Pete Dubler

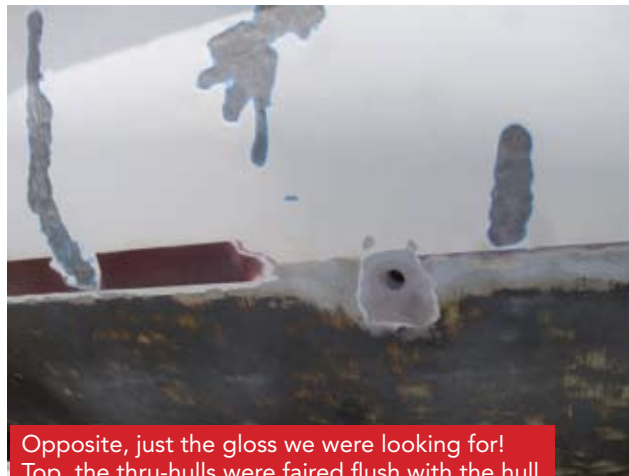
Opposite, just the gloss we were looking for! Top, the thru-hulls were faired flush with the hull. Bottom, after the second application of filler

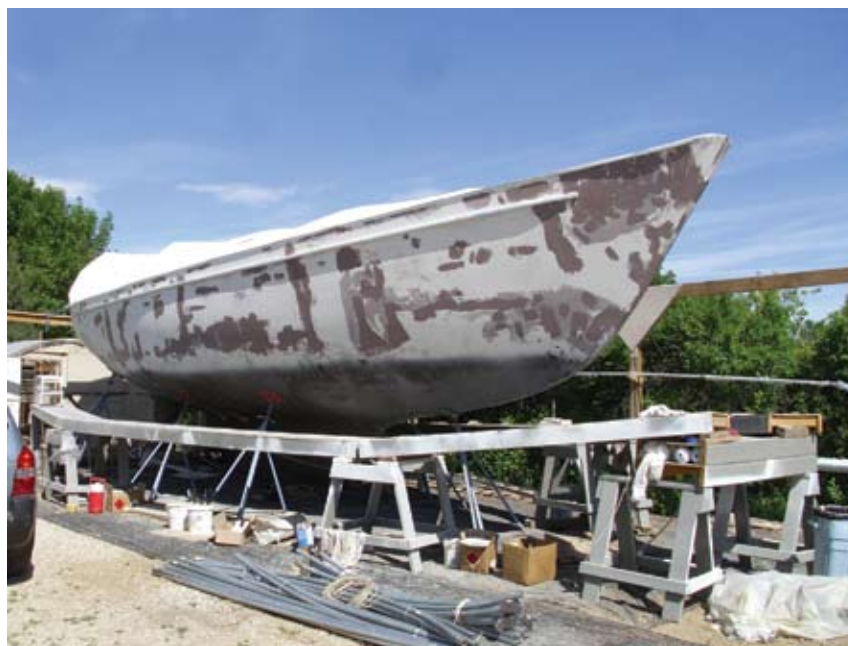
Top, the hull was masked while the boot stripe was sprayed. Bottom, Alex and Pete conduct a tack rag wipe and inspection prior to spraying the topcoat

A few evenings later, I masked off the boot stripe area using the sanded stripe as a guide and sprayed three coats of Topcoat 501 to a green mirror finish. My girls decided there would never again be a wait on board to get into the head as they could get in the dinghy and use the hull as their mirror for putting on makeup. Posting the pictures on my Facebook page elicited any number of “OMG—that’s beautiful” comments. After more than 200 hours of loving work and faith, those OMGs were the ones we were truly after. ≈

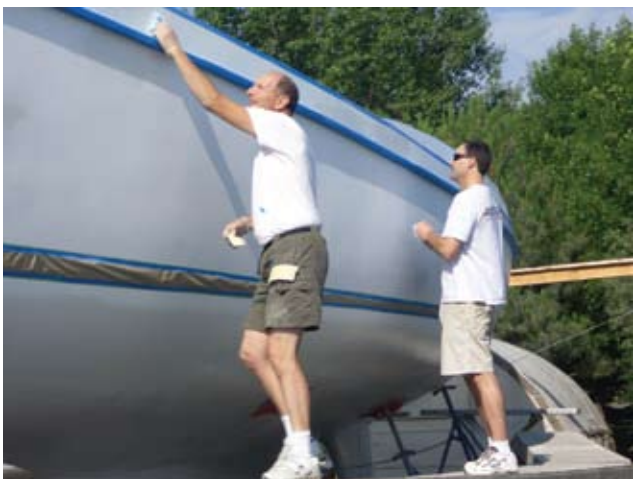
Right, standing at an angle ahead of the spray gun is the way to go. Bottom, the finished product—OMG, indeed

spray gun and demonstrated on the first few feet of the transom. Under his watchful eye, I sprayed the final two coats. To get the ultimate in glossy finishes, we wanted to spray “on the hairy edge” of letting the paint run. Of course, I left a few runs. Enough on the transom and port quarter that I felt compelled to sand that part out and spray it again the next week. Any other smaller runs or flies that decided the paint was so beautiful that they had to end their lives right then and there were rubbed out with a Meguiars 2000-grit sanding block followed by a quick buffing with a medium compound, and finally a polishing compound. It is worth mentioning that Alexseal is unique in that the other well-known aliphatic polyurethane marine paints cannot be sanded and buffed this way since their pigment does not run completely through the top coat. In fact, their warranties are voided if you do, whereas the Alexseal maintenance procedures detail this repair method.
